Inspection Report

Property Address:
1010 Somewhere Ln
Anytown TN 11111

Fogarty Home Inspection Services

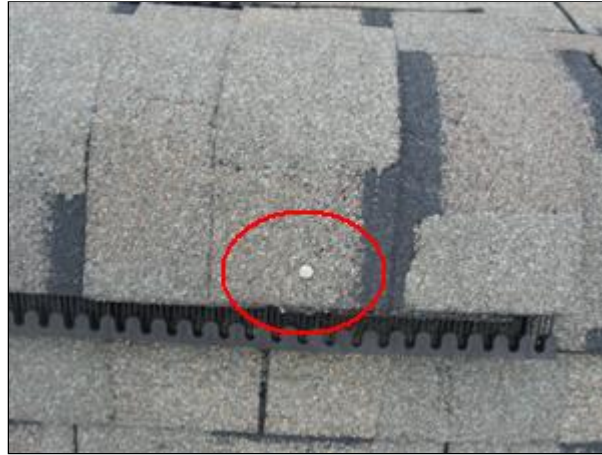
1.2 Picture 1

(1) All of the pipe collar nails, ridge cap nails, and ventilation nails should be caulked or sealed to help prevent leaks. This is normal preventative maintenance with all home, and should be expected. Caulking or sealing should be done every few years years to help prevent leaks.

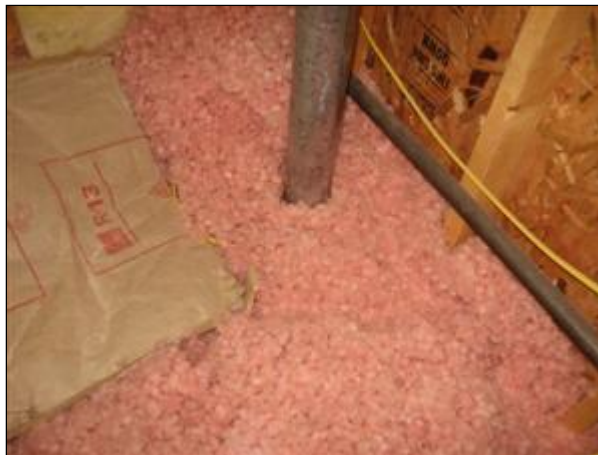
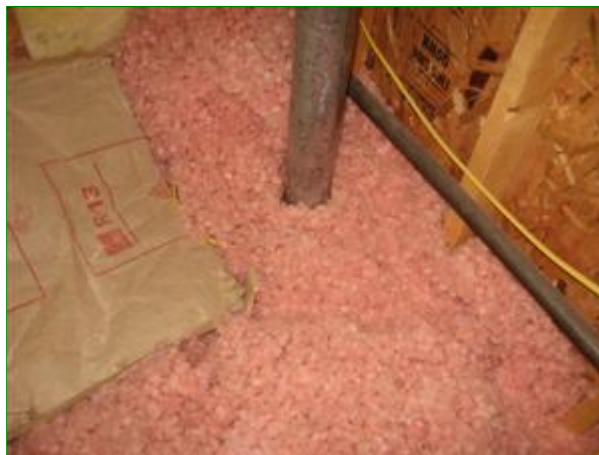
1.2 Picture 3

- ⊕ (2) The hot water heater flue pipe is covered in insulation. 1" minimum clearance should be all the way around for safety reasons.

- ⚠ (2) The hot water heater flue pipe is covered in insulation. 1" minimum clearance should be all the way around for safety reasons.

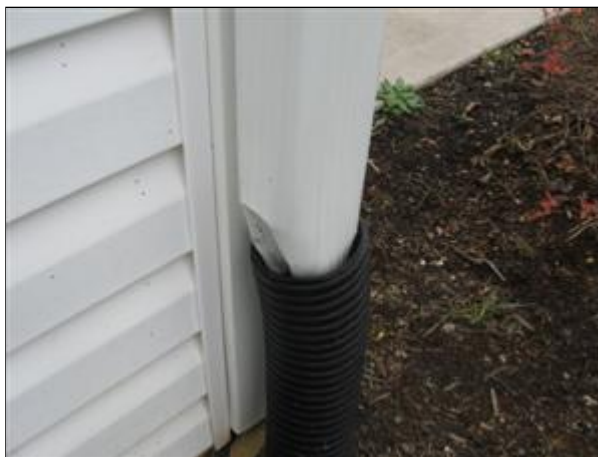
1.4 Picture 1

the gutters are bent smaller at the bottoms to accommodate the plastic tubing. This should be replaced with adapter to ensure proper drainage.

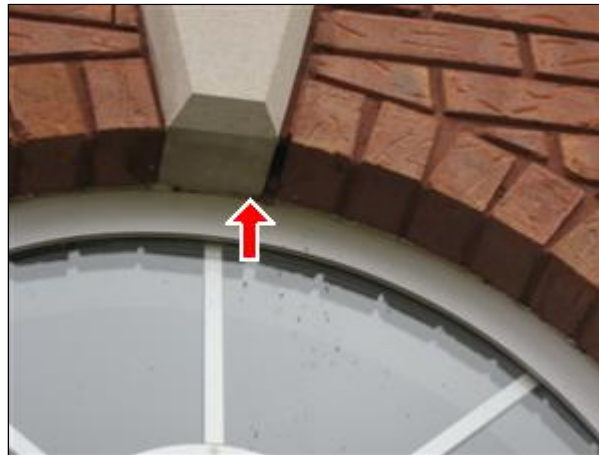
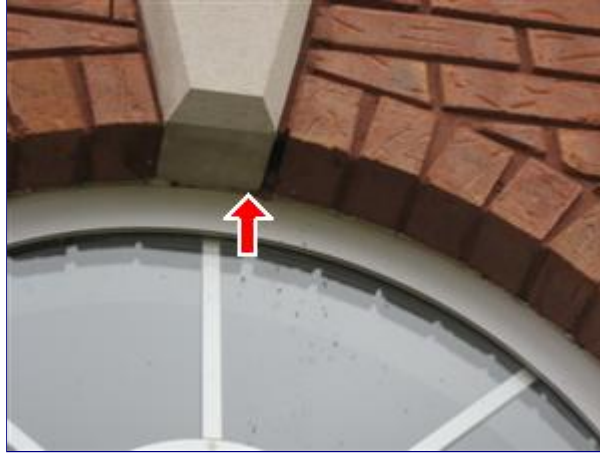
2.0 Picture 1

🔧 (1) There is some mortar missing next to the keystone.

- 🔧 (1) There is some mortar missing next to the keystone.

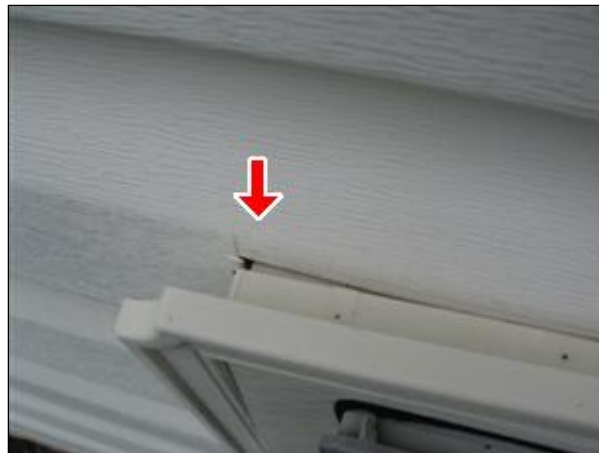
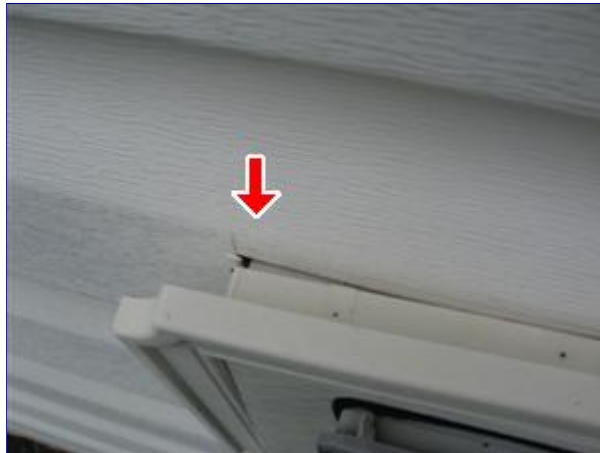
2.0 Picture 2

🔧 (2) The electrical outlet box should be sealed to prevent leaks.

- 🔧 (2) The electrical outlet box should be sealed to prevent leaks.

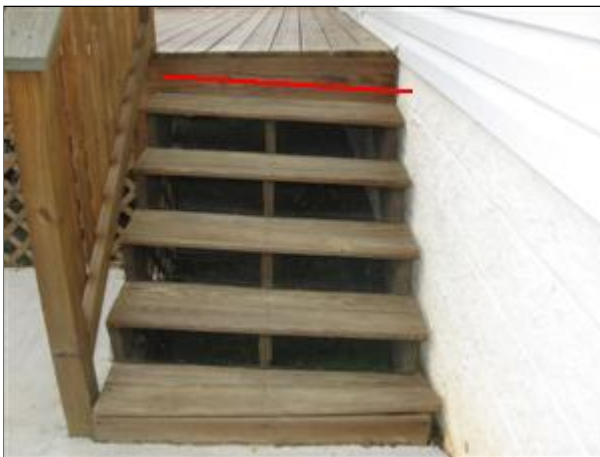
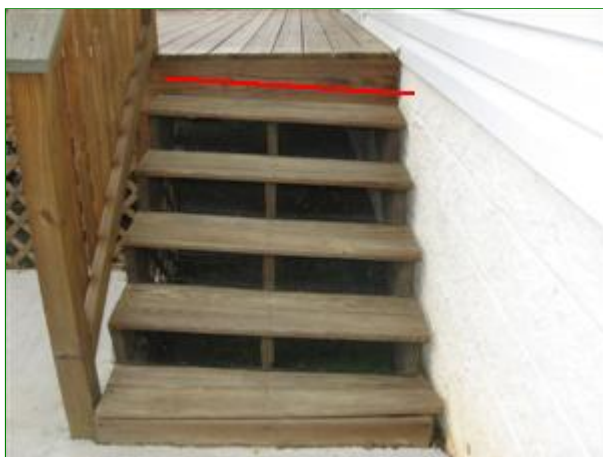
2.3 Picture 1

🚧 The steps are failing on the deck. This should be repaired for safety reasons.

The hangers for the deck joist are undersized and should be larger.

The posts that support the roof have been modified to accommodate the deck. Decks should rest directly over a post. Notching the 6x6 post can weaken the integrity. Further evaluation is needed to know if the posts are safe or need to be replaced. It is your decision as to what repairs should be made.

- + The steps are failing on the deck. This should be repaired for safety reasons.

The hangers for the deck joist are undersized and should be larger.

The posts that support the roof have been modified to accommodate the deck. Decks should rest directly over a post. Notching the 6x6 post can weaken the integrity. Further evaluation is needed to know if the posts are safe or need to be replaced. It is your decision as to what repairs should be made.

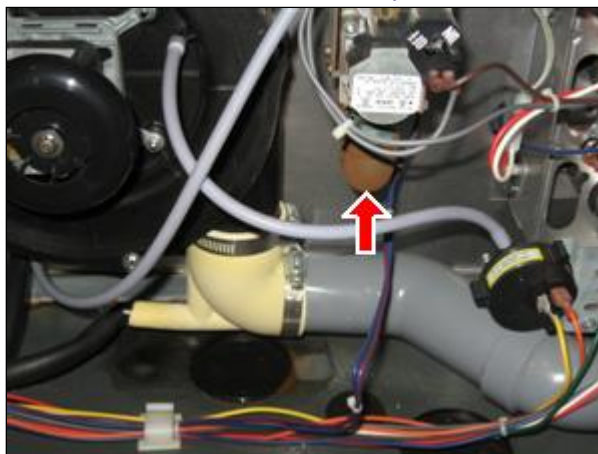
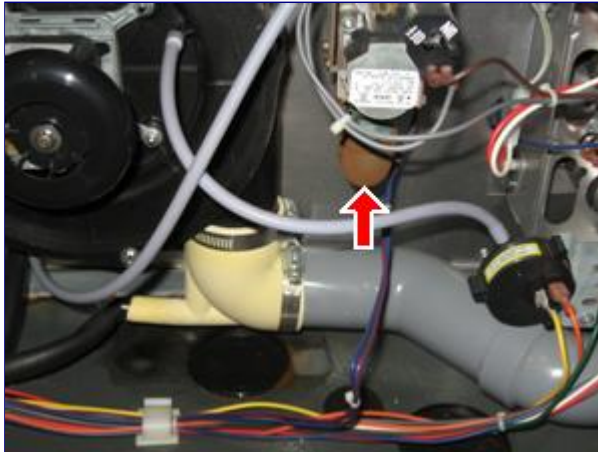
10.0 Picture 1

- 🔧 The gas furnace is gurgling and draining water into the furnace and the pan below. There is also a gas leak on one of the fittings inside the furnace. I would recommend a licensed hvac person to evaluate and service the unit,

The gas furnace is gurgling and draining water into the furnace and the pan below. There is also a gas leak on one of the fittings inside the furnace. I would recommend a licensed hvac person to evaluate and service the unit,

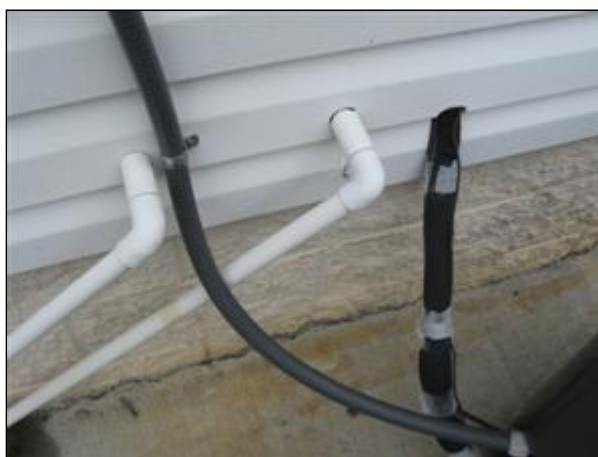
10.3 Picture 1

The drain tubing is not glued together.

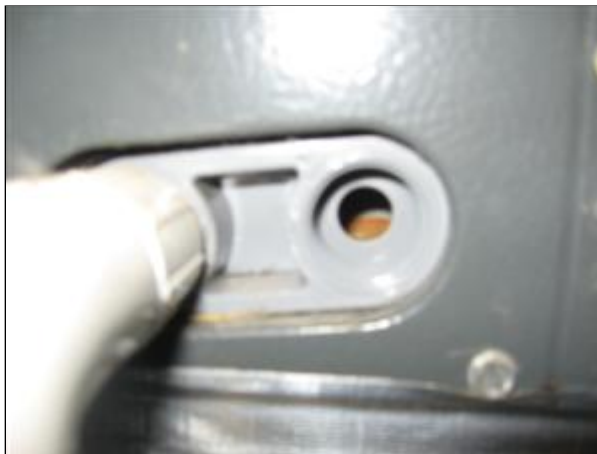
10.7 Picture 1

(2) The extra drain line plug needs to be sealed.

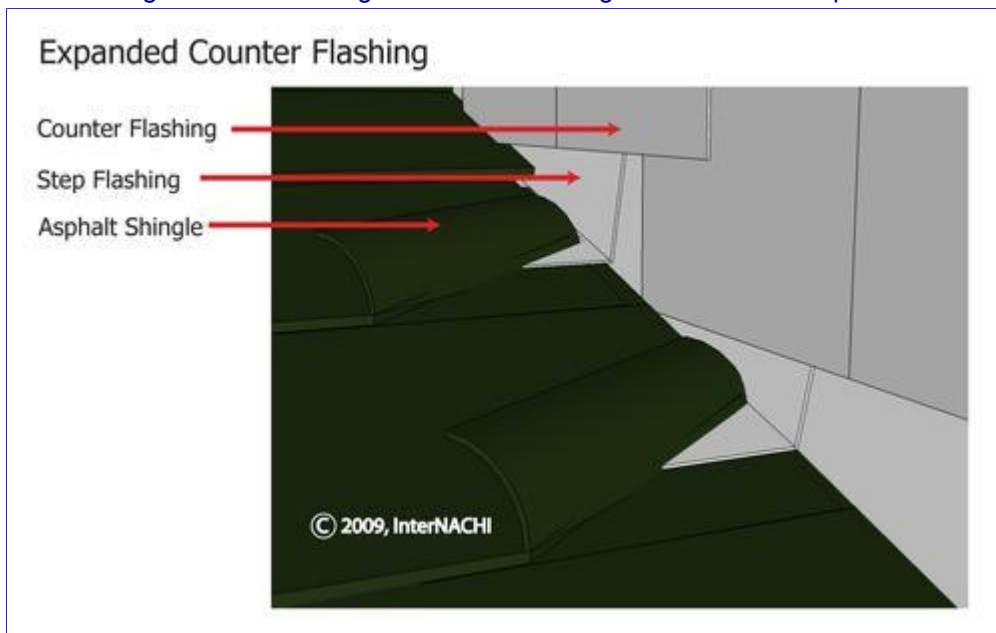
1.1 Picture 1

🔧 There is no counter flashing above the roof against the brick siding. This should be repaired.

There is no counter flashing above the roof against the brick siding. This should be repaired.
