Summary

Mr. Sample Inspection

123 Home buyer rd
Pigeon Forge TN 37863

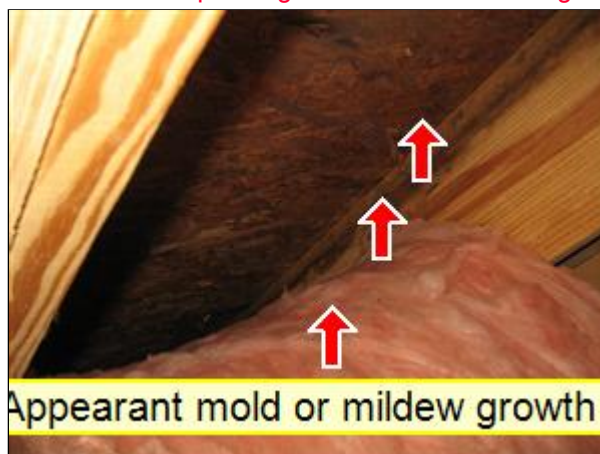
1.5 Picture 1

🚫 Upon further investigation it was discovered that the reason that the roof had questionable areas, was the cause of improper installation of the roof insulation and possibly the plumbing vent . Insulation was removed in one section, and possible mold or mildew growth was discovered on the roof sheathing. The roof sheathing also shows signs that it was

beginning to deteriorate. This area will need to be further evaluated so you will know the extent of the problem. If the entire roof area does have mold you should consider getting it remediated professionally. The entire roof structure and plywood may also need to be removed in areas depending on the extent of damage.

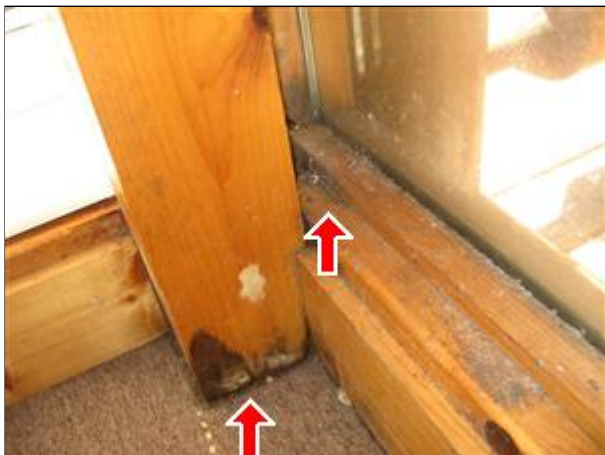
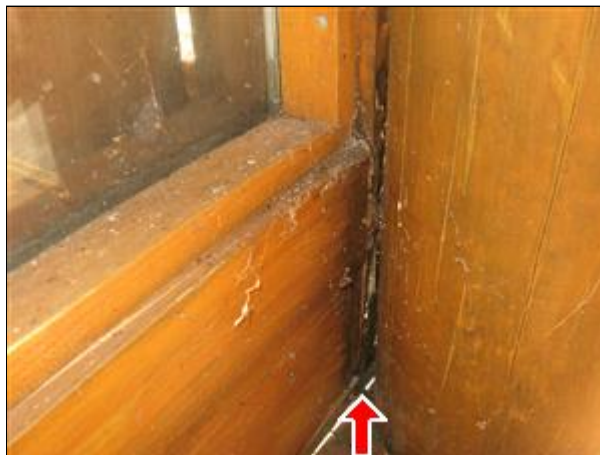
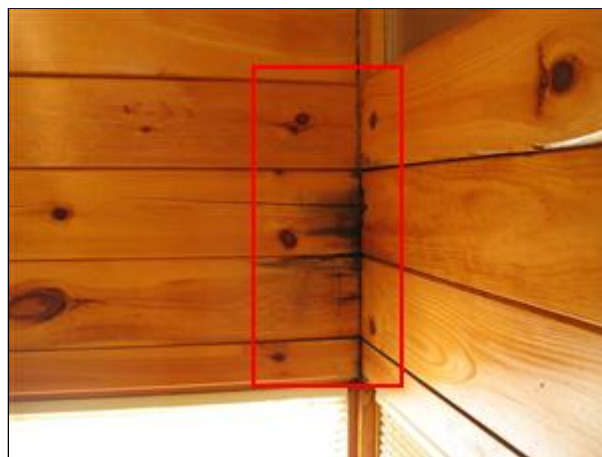
- ⊘ (1) The front corner of the home where the hot tub is located at, shows signs of moisture intrusion all the way down to the bottom of the floor. This was evident in several areas inside the home behind the stairs. I could not determine if this is from the tub or the rain penetrating this area. This area will need to be sealed and maintained to prevent further water intrusion.

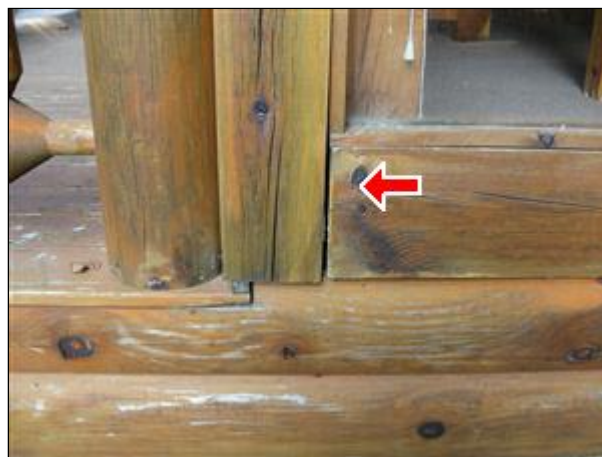
2.0 Picture 4

- ⚒ (2) There were numerous areas where gaps and checking in and around the wood surface were found that needs sealed. This can be periodic maintenance with log style homes, but some areas are large enough to see daylight through.

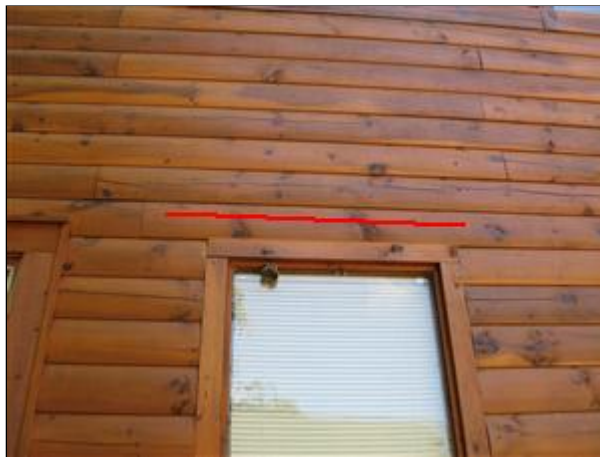
2.2 Picture 1

- 🔧 (1) Some of the windows are not flashed or covered on the top. If these are not sealed and maintained they could leak.

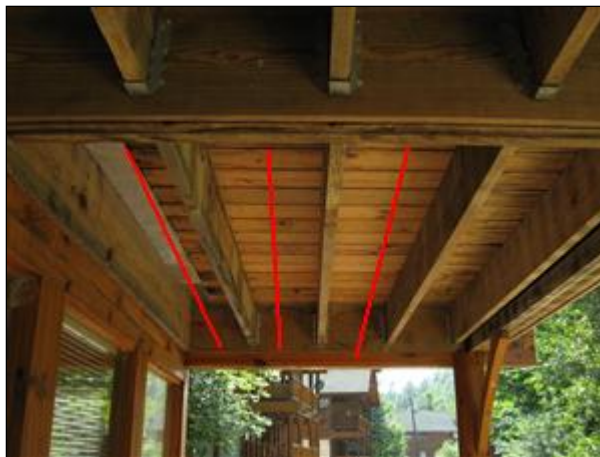
2.3 Picture 1

- 🇨🇷 (1) You should consider adding more joists below the area where the hot tub sits. The overall construction looks sufficient, but a load calculation would need to be done to determine if the tub is overloading the deck.

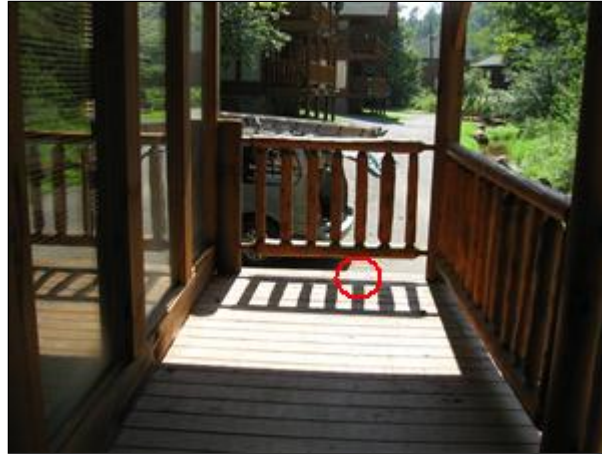
2.3 Picture 2

(2) The bottom railing is too high. If you have small children you should cover both decks in this area to prevent injury or death.

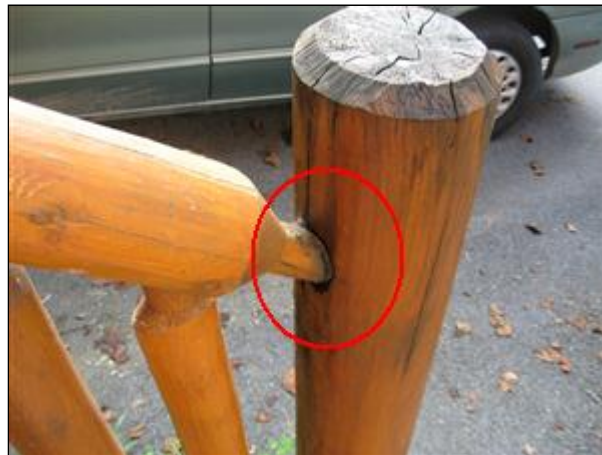
2.3 Picture 3

(3) The deck was flashed with aluminum. Aluminum sometimes will corrode for the chemicals of pressure treated wood and start to fail. You should watch this area and make repairs when needed.

(4) The front handrail is broken and needs repair.

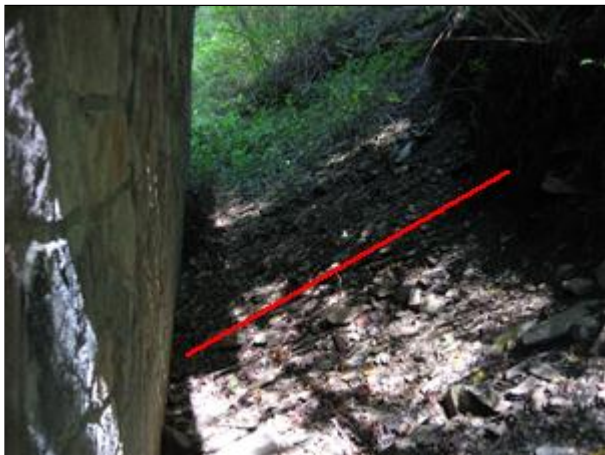
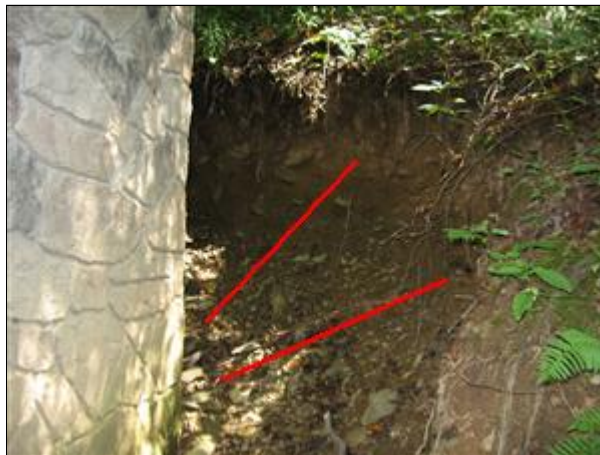
- ⊘ There is a negative slope towards the rear and the back sides of home. Also the right side of the home under the decking. This area does not appear to drain water away from home and needs landscaping and drainage corrected.

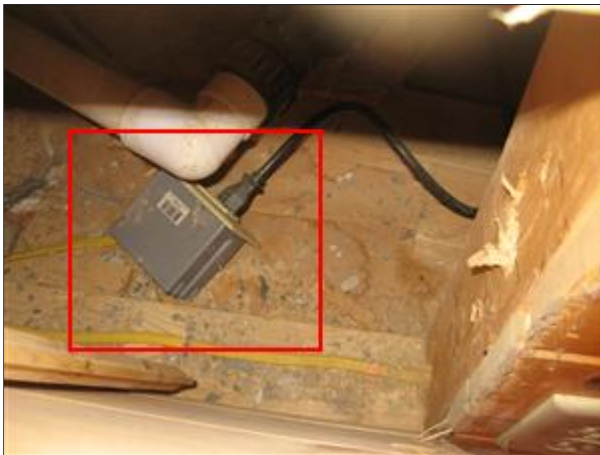
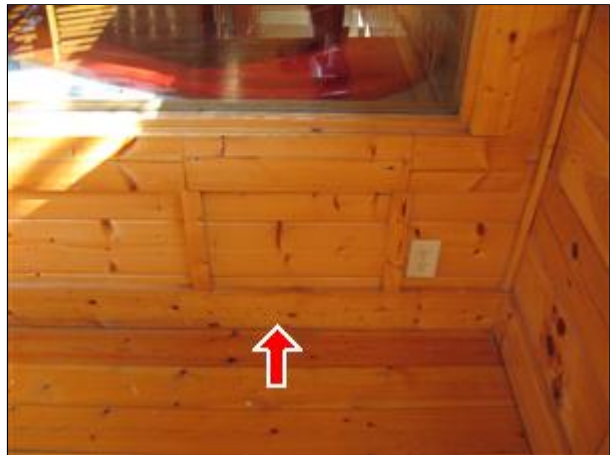
+ The ground fault receptacle for the whirlpool tub was found lying on the floor. This needs to be secured properly in the event water overflows.

There also need to be an actual vent installed to provide the tub with proper air circulation.

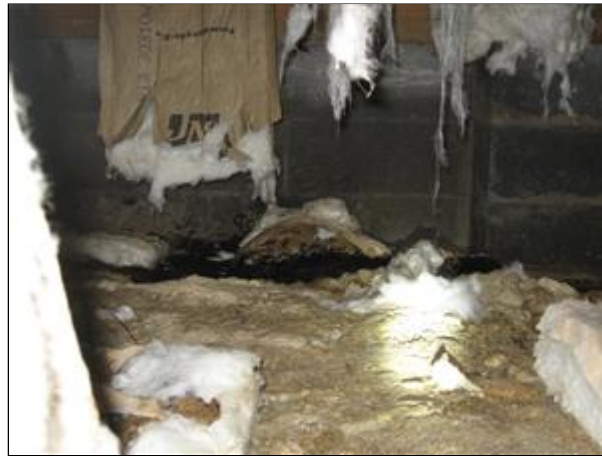
6.0 Picture 1

- ⊘ (1) Visible signs of water intrusion in the crawlspace are present from standing water and from dampness. Water intrusion if not corrected can lead to other problems including mold and cause excessive moisture to floor system that can lead to deterioration and increased repair cost.. I recommend further investigation or correction by a qualified licensed contractor or water infiltration specialist.

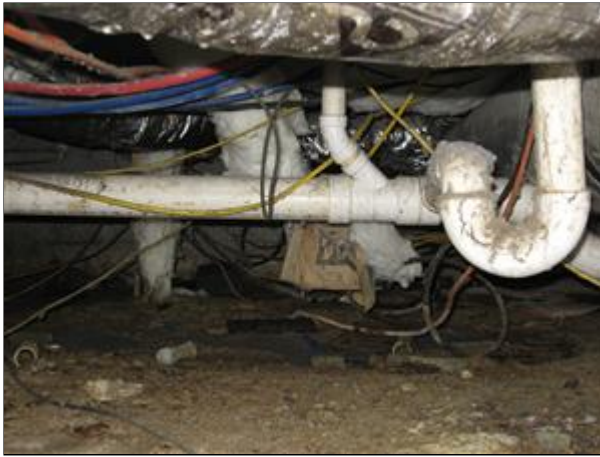
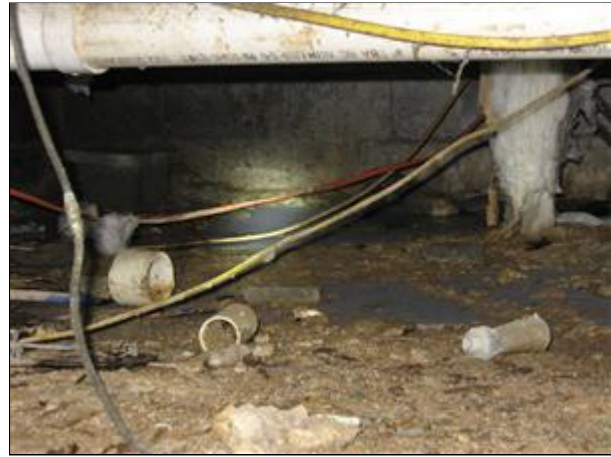
- ⊘ (2) The overall condition of the crawlspace showed a significant amount of repairs needed. The entire crawlspace could not be fully inspected due to several inches of standing water in the back area. Most of the insulation was deteriorating or showing signs of mold growth from sitting on the ground. All aspects of the crawlspace need attention.

Water intrusion will need to be remedied or the moisture issues will continue.

Recommend you get proper mold air samples or testing done. If testing shows signs of problems, then a qualified mold remediation specialist can give estimates on cleanup.

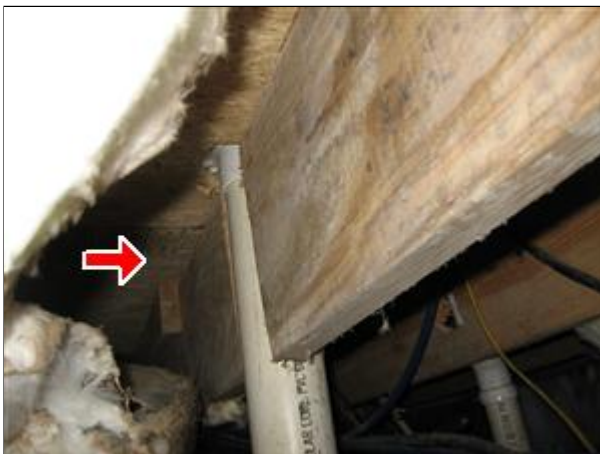
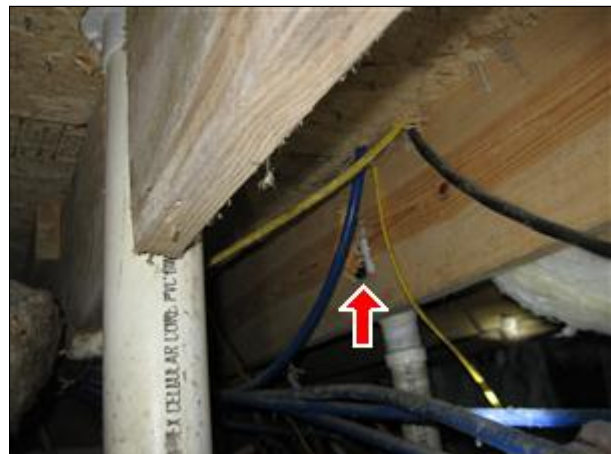
- ⊘ (1) At least Two floor joist(s) are cut or damaged by Tradesman under the Master Bedroom and Kitchen. Repairs are needed. .

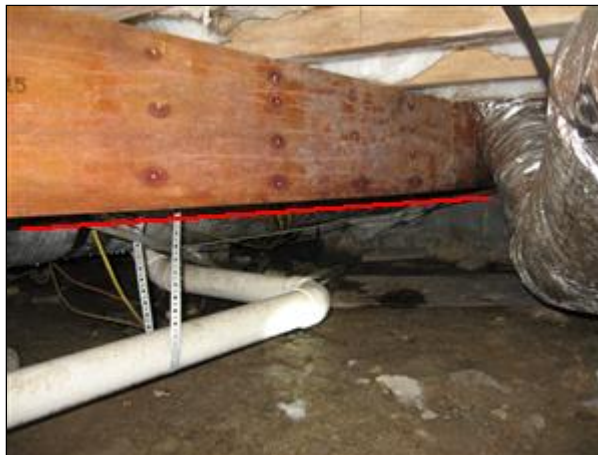
6.3 Picture 3

- ⊘ (2) The center support beam is starting to sag and has allowed the floors in the home to settle. This will need extra support and repairs to stop the settling.

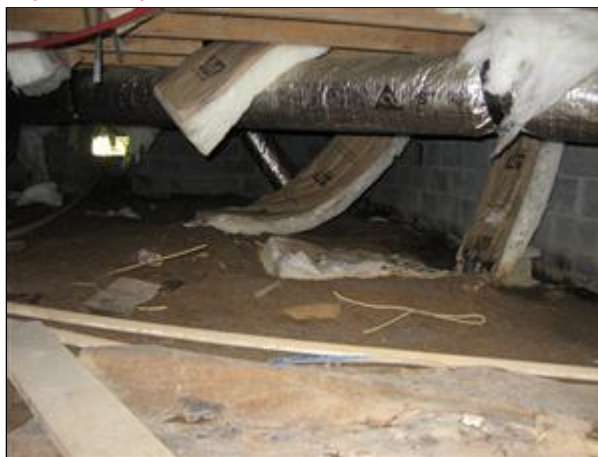
6.5 Picture 1

- ⊘ The insulation is loose/fallen, is deteriorated in areas and covered with possible mold or mildew growth. in the crawlspace. A large majority if not all of the insulation will need to be removed due to the damage and possible mold growth.. A qualified person should repair or replace as needed.

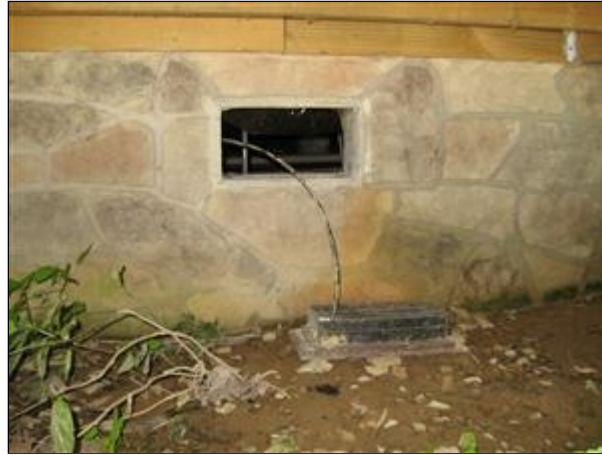
6.7 Picture 1

🔧 Two foundation vents are loose or missing at the front and sides of home. Rodents, reptiles or insects could enter into crawlspace. .

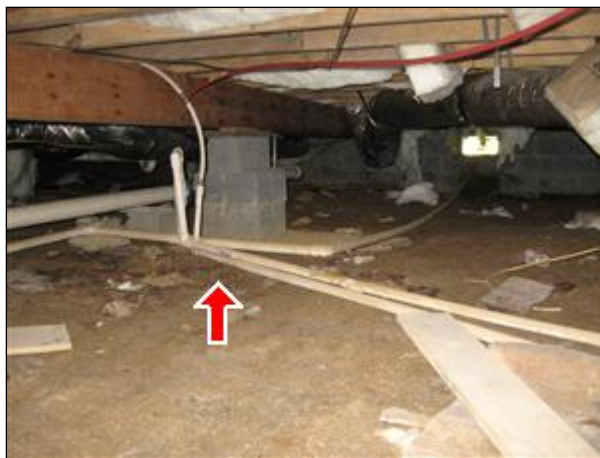
7.0 Picture 1

- (1) The plumbing supply is resting on the ground. This should be protected or secured in some way to prevent damage or leaks.

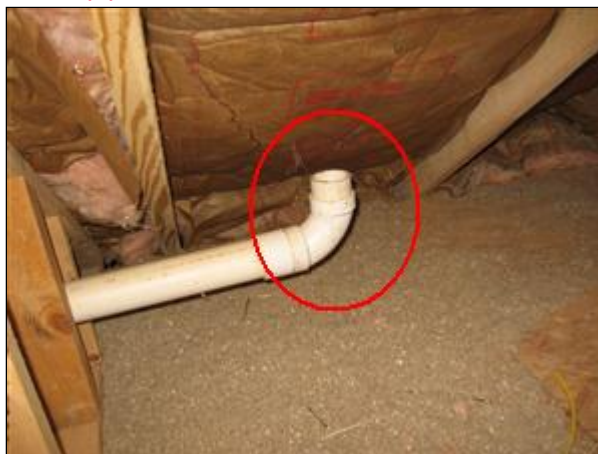
7.1 Picture 1

- ⊘ (2) The only vent found for the fixtures terminated into the small attic space. There was no mechanical vent installed to prevent sewer gas from leaking out. This pipe should have been vented out of the roof.

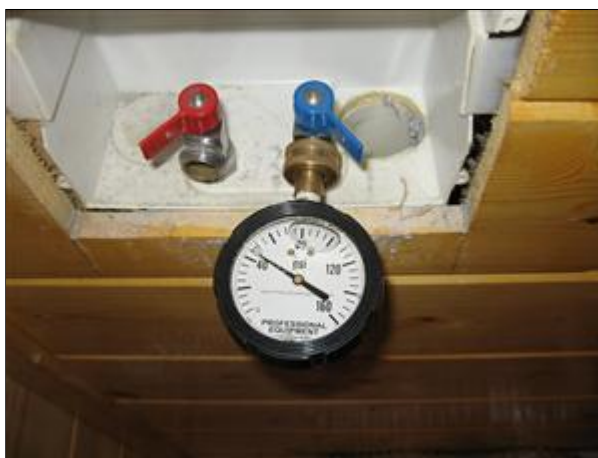
7.2 Picture 1

Normal water pressure ranges should be from 60 to 80 psi. Anything higher than this can cause damage to water lines and fixtures.

Water Pressure is 43 psi

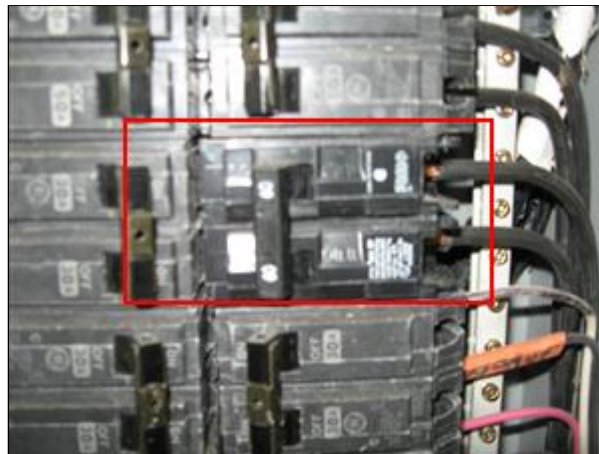
8.1 Picture 1

+ At least two circuit breakers in main panel are of a different brand than panel manufacturer. The manufacturer requires that in order for the panel to be safe, only their brand is allowed to be used inside the panel. Even though these circuit breakers are all "UL approved," they are not approved to be used in panels of different manufacturers unless so indicated on the panel label.

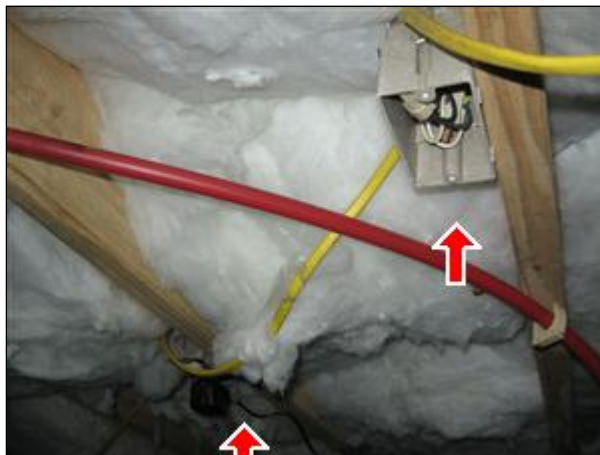
8.4 Picture 1

- ✚ At least three junction boxes were found missing protective cover plates in the crawlspace. This is a safety issue that needs correcting.

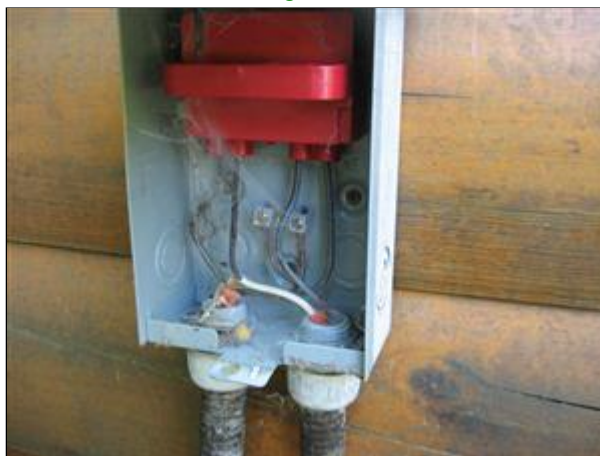
9.3 Picture 1

+ The protective covers for all safety disconnects are missing. This can cause an electrical injury and should be repaired.

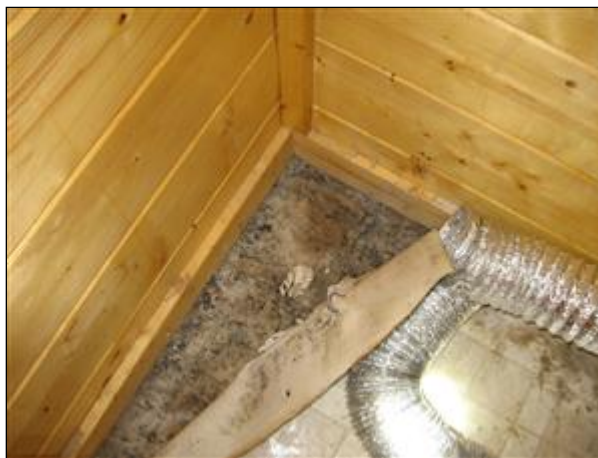
10.2 Picture 1

- +** The flooring under the linoleum shows signs of water damage and also possible mold growth. This could have been from a previous leak.

The flooring is loose on the floor.
