Inspection Report

Property Address:
1200 Parrot Head Way
Key West FL

Fogarty Home Inspection Services

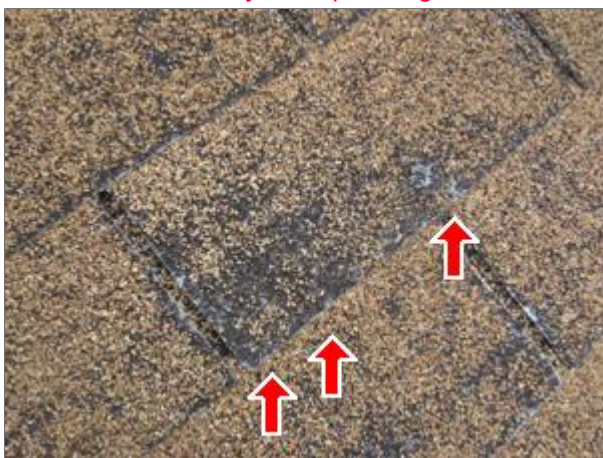
1.0 Picture 1

⊘ The roof covering has reached the end of its life expectancy. The covering does need to be replaced. While it could last a year or so, some areas may need patching as leaks develop. Recommend roofer to evaluate further.

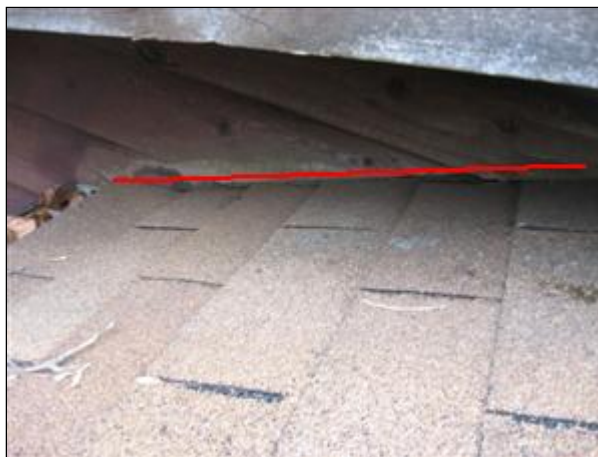
1.1 Picture 1

- 🔧 There does not appear to be any flashing where the roof meets the side of the home. This can be repaired with the new roof.

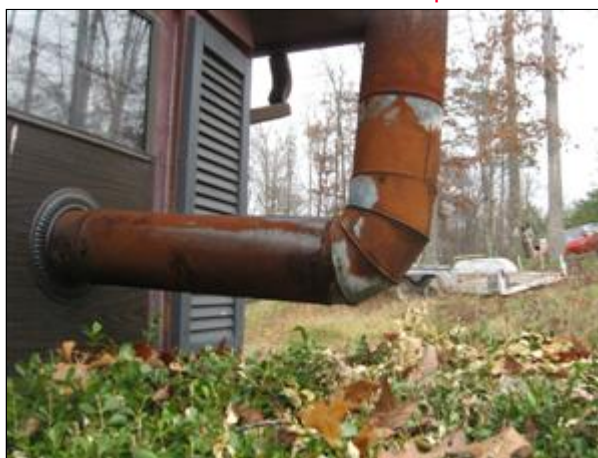
1.2 Picture 1

- ⊘ (1) The pipe collars are deteriorated, and need replacing.
- ⊘ (2) The stove pipe is badly deteriorated and should not be used until replaced.

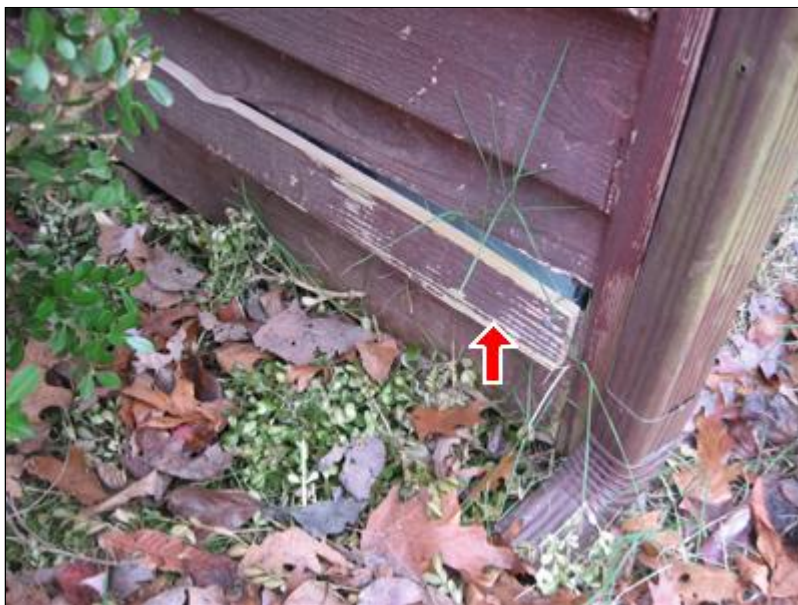
2.0 Picture 1

- (1) The siding will need paint caulking and maintenance. The overall condition appears good. There are a few broken boards and some minor insect and water damage, but overall in fair shape. If the maintenance is not addressed the siding will deteriorate further.

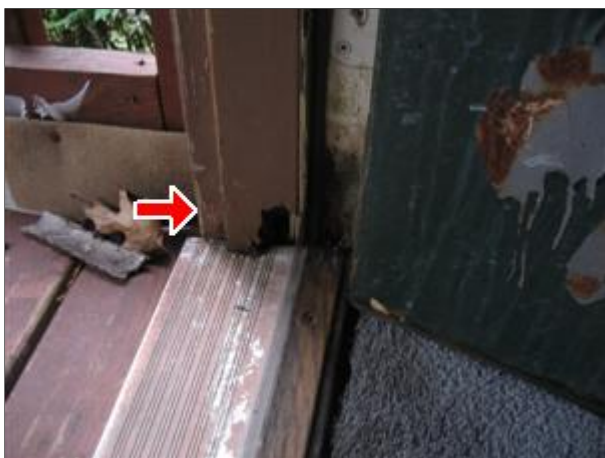
2.1 Picture 1

The front door is corroded, and the wood trim is deteriorated at the bottom.

The side door is loose at the bottom hinge and does not close easily.

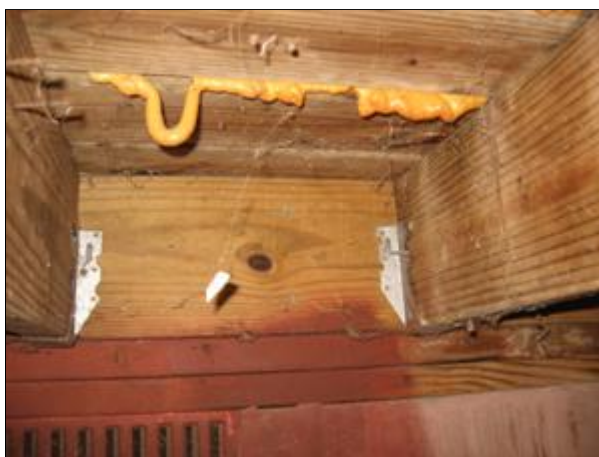
2.3 Picture 2

Not having a deck bolted can result in it to pull away from the home and cause injury or death.

I recommend the overall condition be evaluated by a professional, and the noted deficiencies plus any other recommendations be made prior to closing if you choose to.

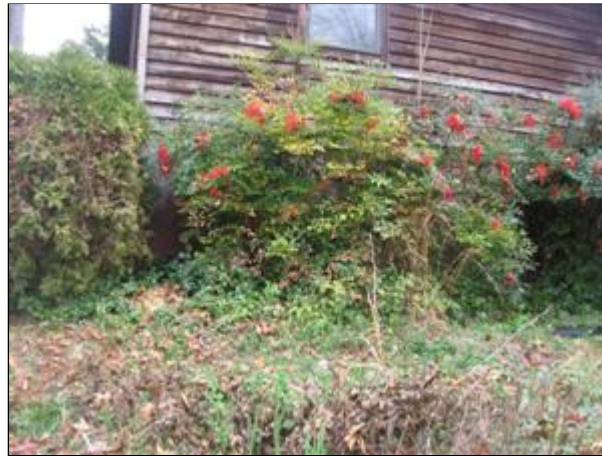
2.4 Picture 1

🔧 (1) There are several bushes and trees blocking a full view of the structure.

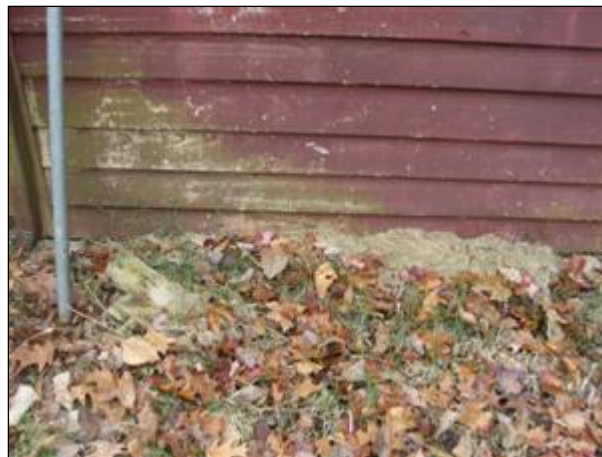
2.4 Picture 2

🔧 (2) There are a couple of places where the siding is covered by dirt and debris. This should be removed to prevent wood rot.

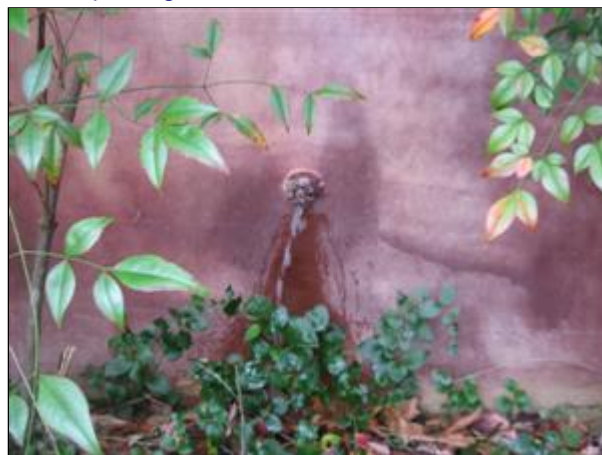
2.6 Picture 1

🔧 Both hose bibs are damaged and need replacing.

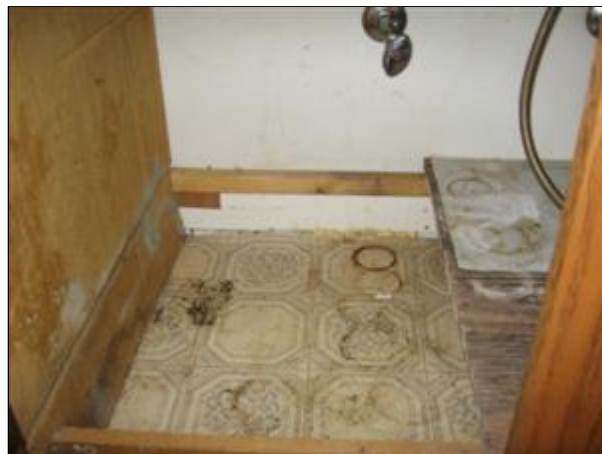
3.4 Picture 1

The sink cabinet is missing the floor in one section.

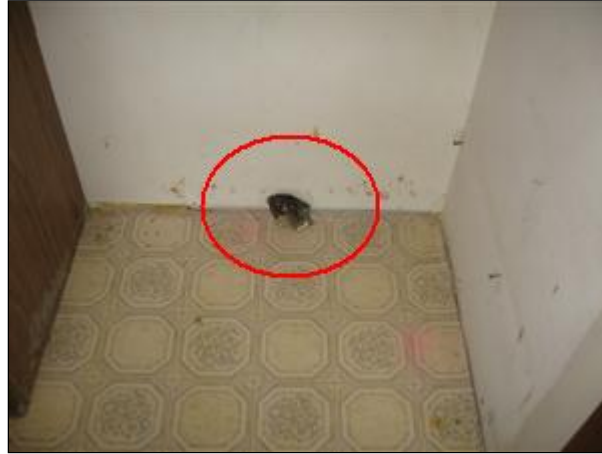
3.7 Picture 1

There is no cover on the stove outlet. This is a safety issue that needs correcting.

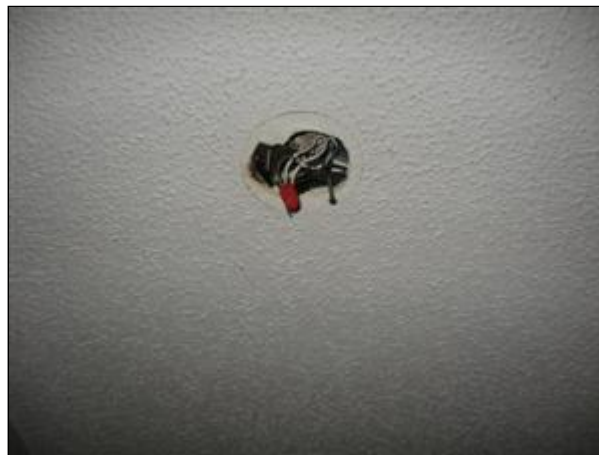
4.4.C Picture 1

- 🔧 There is no light fixture in the hallway.

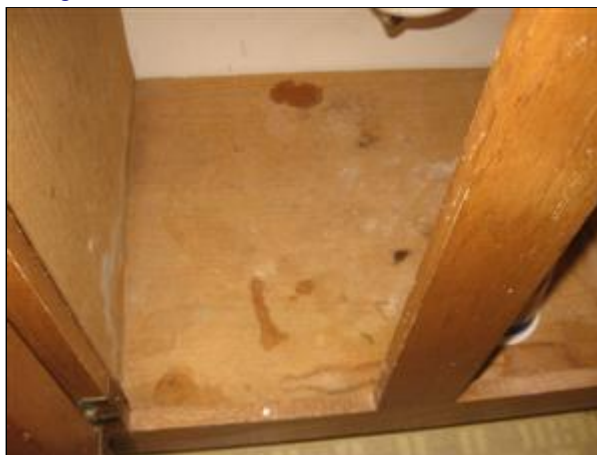
5.0.A Picture 1

The floor of the cabinet is water damaged.

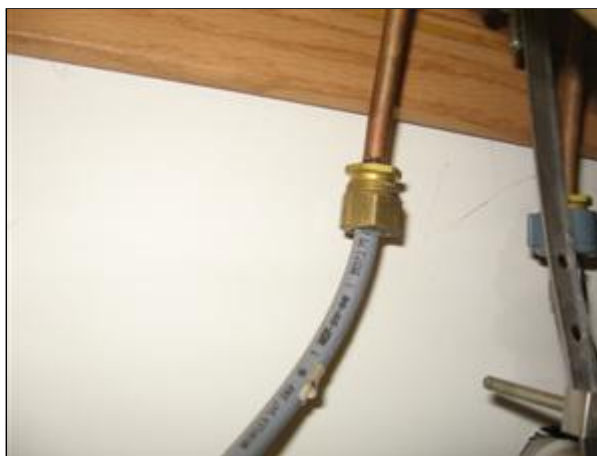
5.3.A Picture 1

(1) The sink faucet leaks at the hall bath. Repairs are needed to stop leaking water from damaging the cabinet bottom or to eliminate moisture that may contribute to fungi growth. A qualified licensed plumber should repair or correct as needed.

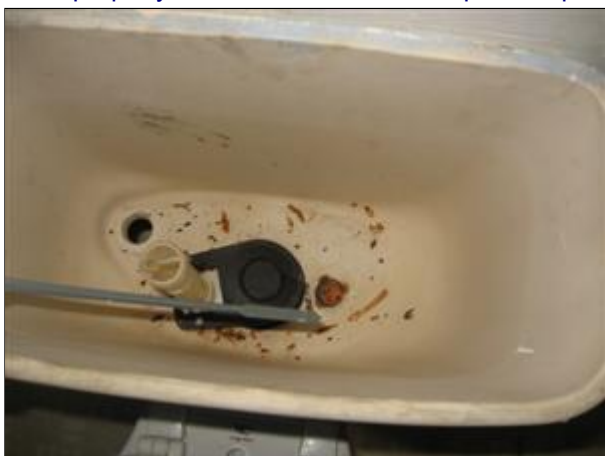
5.3.A Picture 2

(2) The tub faucet and fixture is loose in the wall. It is also damaged and will need replacing.

The shower head is damaged and needs replacing

- 🔧 (3) The toilet is not connected and the components were removed from the tank. The toilet is also not the original and might not be properly installed on the floor. A qualified plumber should repair these issues.

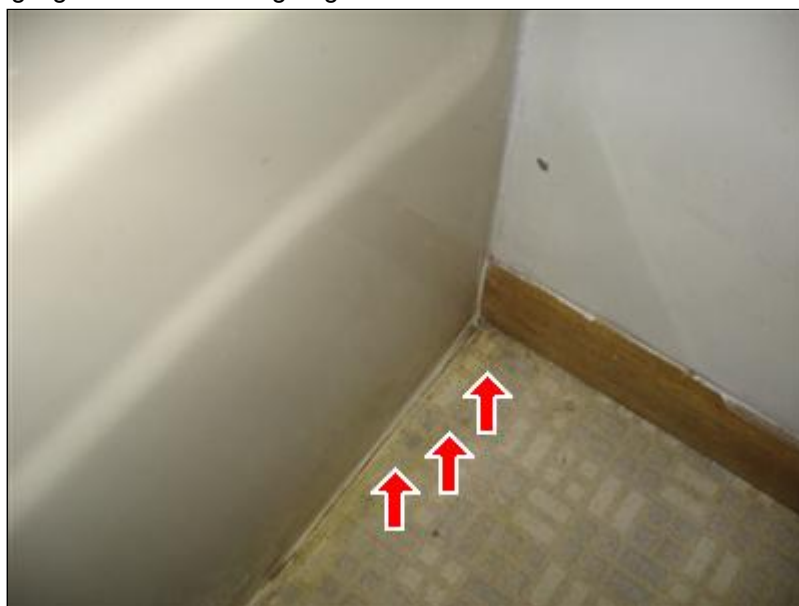
5.3.A Picture 4

- (4) The flooring is showing signs of water damage against the tub.

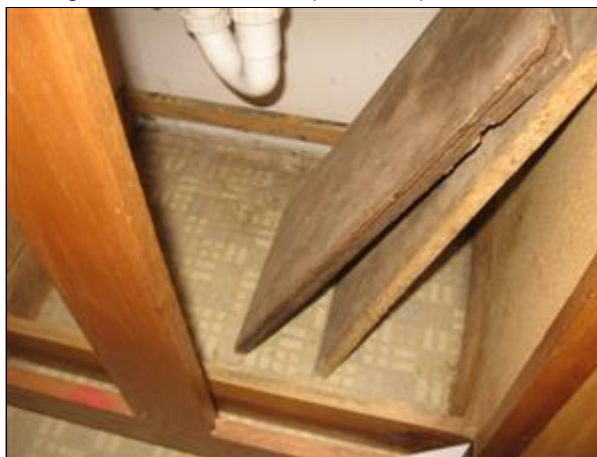
5.0.B Picture 1

- 🔧 Base cabinetry in master bath is damaged. I recommend repair or replace as necessary.

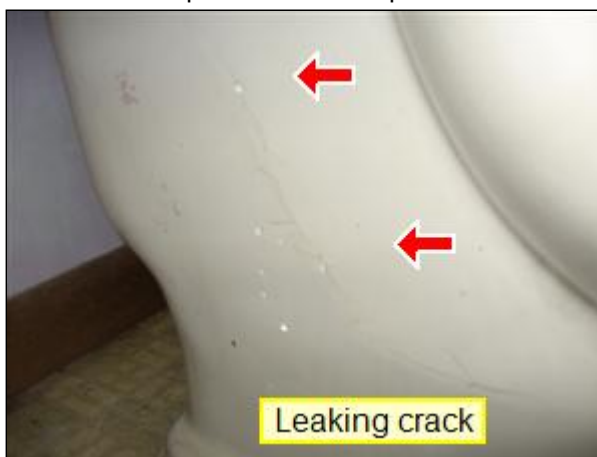
5.3.B Picture 1

- 🔧 (1) The cold water valve is turned off. There was evidence of a major leak inside the cabinet. The vanity will need replacing and the water valve will need further investigating to find the leak.
- 🔧 (2) The control knob on the faucet leaks when moved.
- (3) The toilet is damaged at the master bath. A qualified licensed plumber should repair or correct as needed.

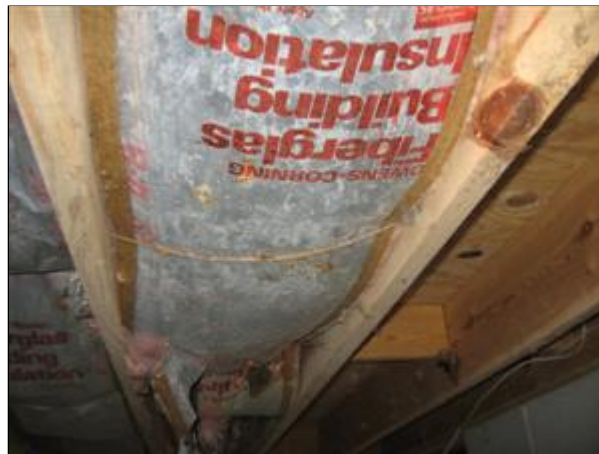
6.5 Picture 1

All of the insulation is installed backwards. Some is damaged and missing.

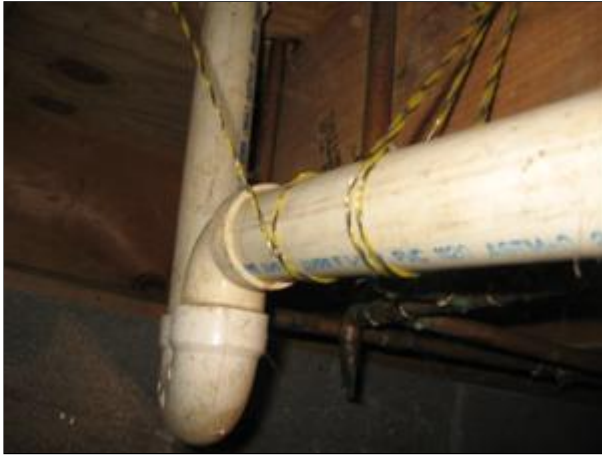
7.0 Picture 1

- (1) A couple of leaks were found under the home. One where the tub is located, and one at a joint connection near the tub. Also a piece of rubber was used to cap off a line. This is improper and should be repaired. A licensed plumber should evaluate and make repairs.

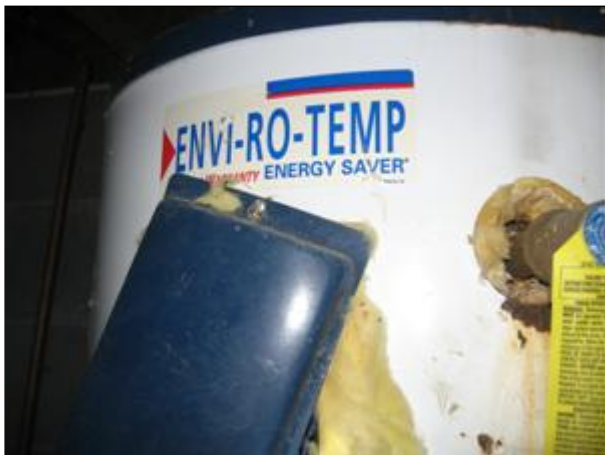
7.2 Picture 1

- ⊘ The water heater is not operating and appears to be badly corroded., Recommend further evaluation and replacement if needed.

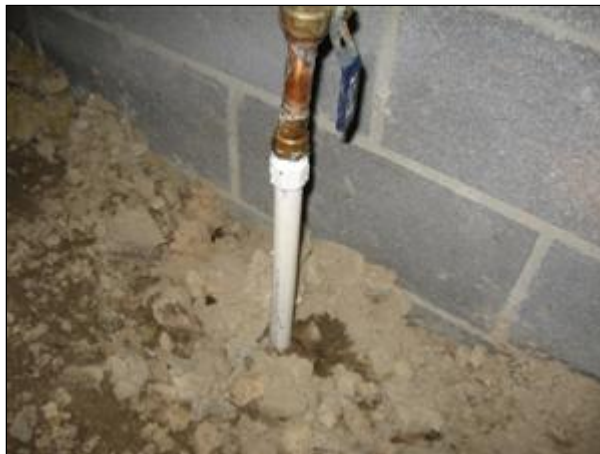
7.3 Picture 1

- 🔧 The main shut off is leaking at the connection.

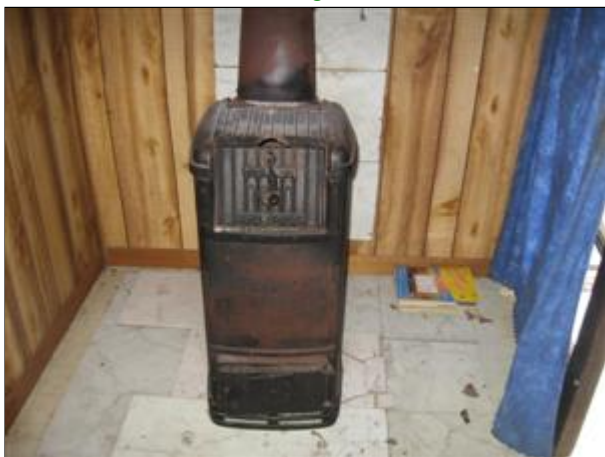
9.6 Picture 1

+ The woodstove does not appear to be safe and needs to be inspected further. The safety features installed to reflect the heat are made of wood and flooring tile. This is unsafe and needs replacing.

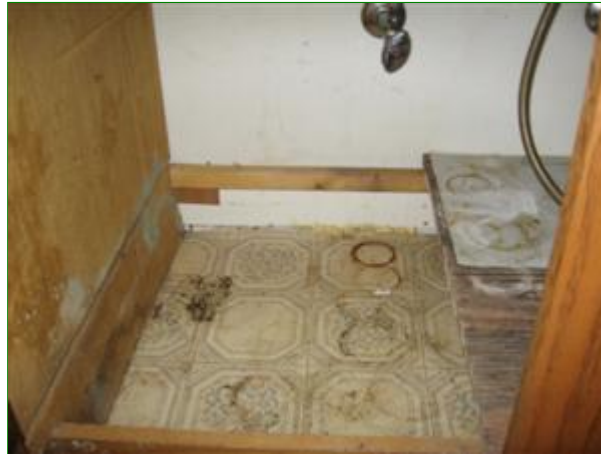
3.4 Picture 1

The sink cabinet is missing the floor in one section.

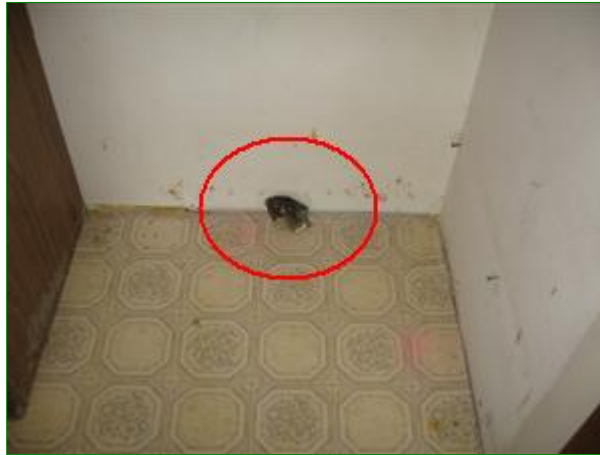
3.7 Picture 1

There is no cover on the stove outlet. This is a safety issue that needs correcting.

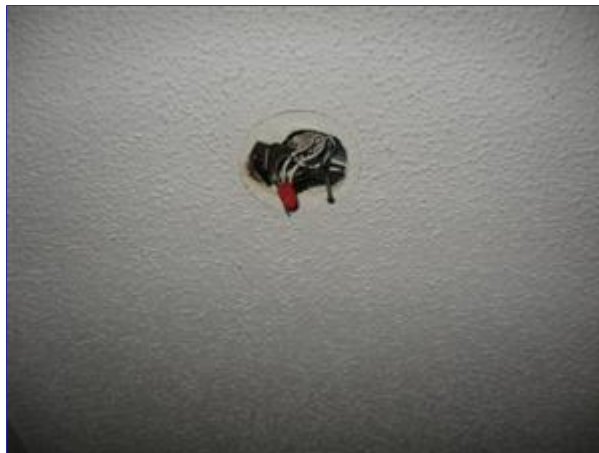
4.4.C Picture 1

- 🔧 **+** There is no light fixture in the hallway.

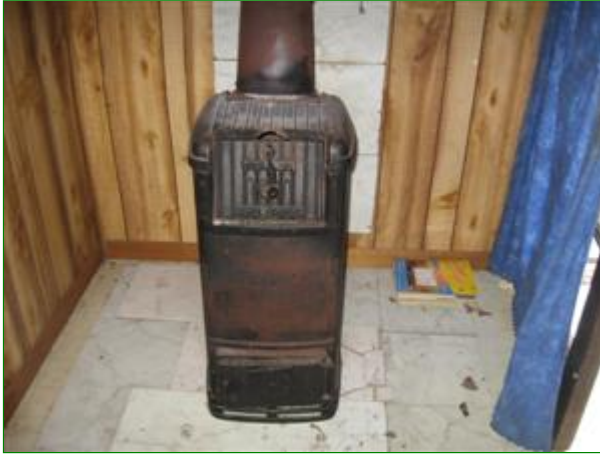
9.6 Picture 1

- +** The woodstove does not appear to be safe and needs to be inspected further. The safety features installed to reflect the heat are made of wood and flooring tile. This is unsafe and needs replacing.

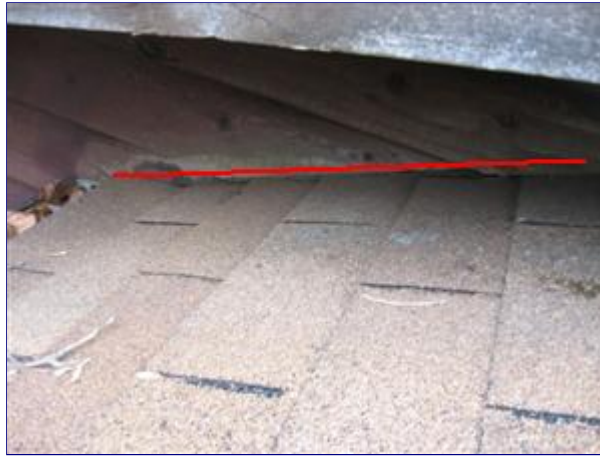
1.1 Picture 1

There does not appear to be any flashing where the roof meets the side of the home. This can be repaired with the new roof.

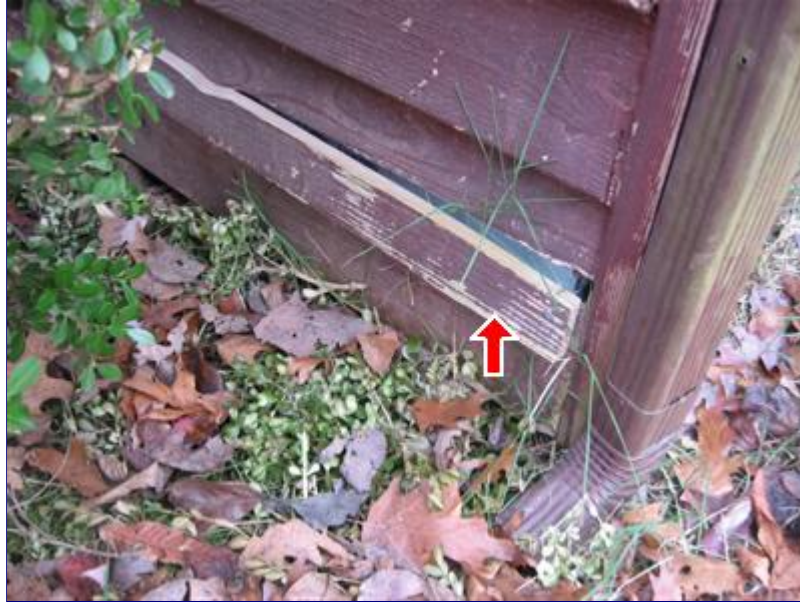
2.0 Picture 1

- (1) The siding will need paint caulking and maintenance. The overall condition appears good. There are a few broken boards and some minor insect and water damage, but overall in fair shape. If the maintenance is not addressed the siding will deteriorate further.

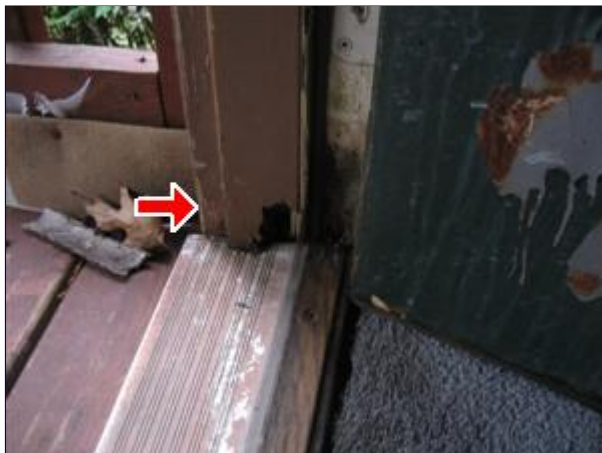
2.1 Picture 1

The side door is loose at the bottom hinge and does not close easily.

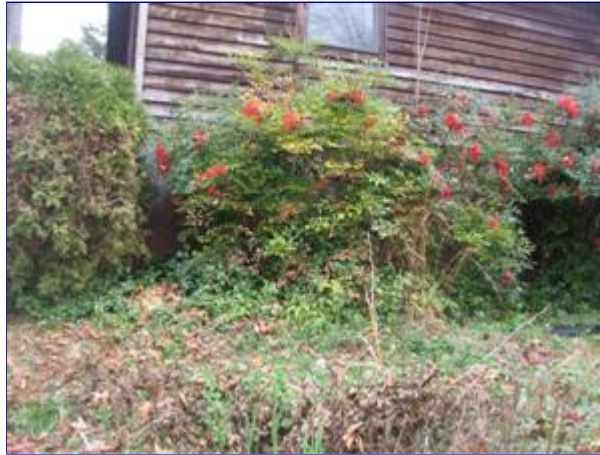
2.4 Picture 1

- (1) There are several bushes and trees blocking a full view of the structure.

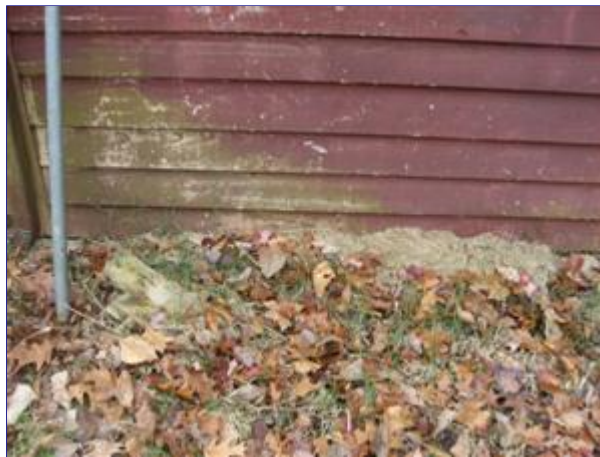
2.4 Picture 2

- (2) There are a couple of places where the siding is covered by dirt and debris. This should be removed to prevent wood rot.

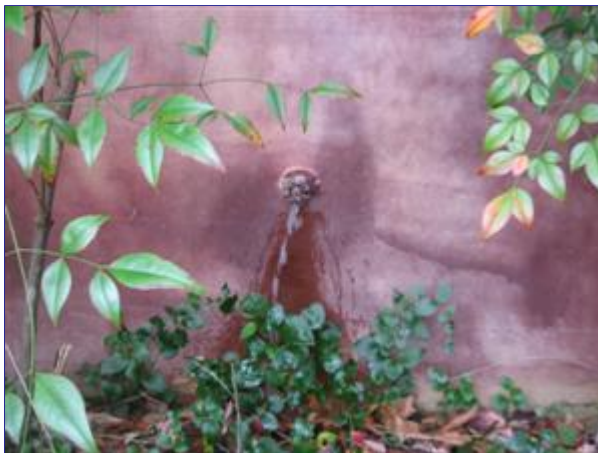
2.6 Picture 1

- Both hose bibs are damaged and need replacing.

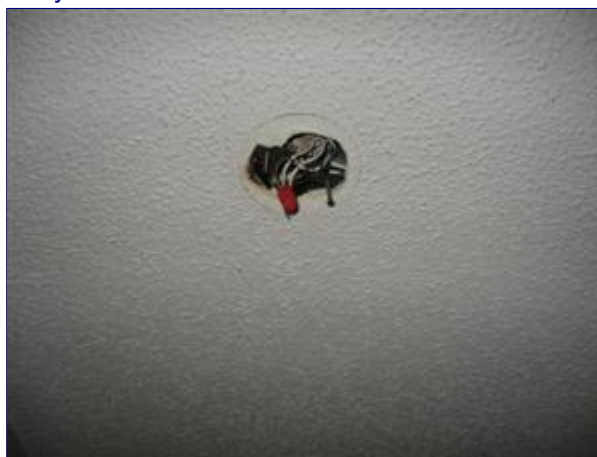
4.4.C Picture 1

There is no light fixture in the hallway.

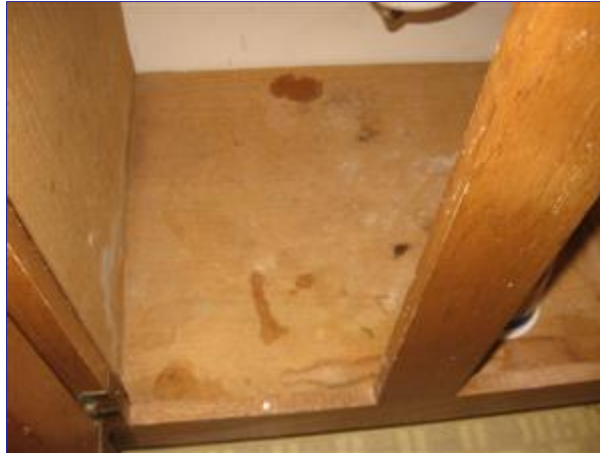
5.0.A Picture 1

The floor of the cabinet is water damaged.

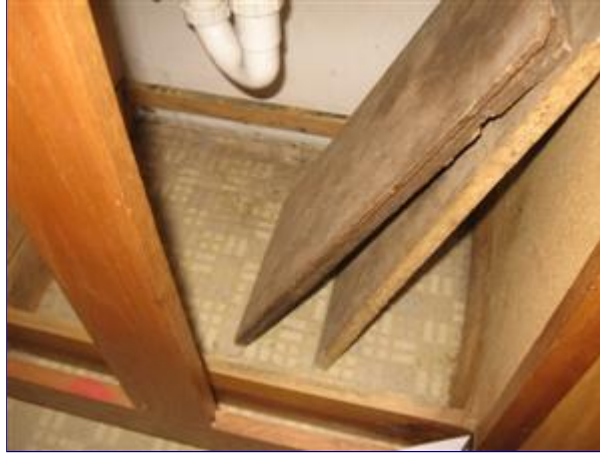
5.0.B Picture 1

Base cabinetry in master bath is damaged. I recommend repair or replace as necessary.

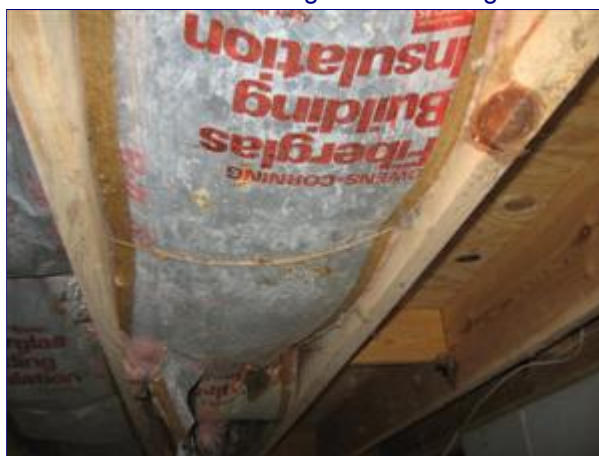
6.5 Picture 1

- ✎ All of the insulation is installed backwards. Some is damaged and missing.

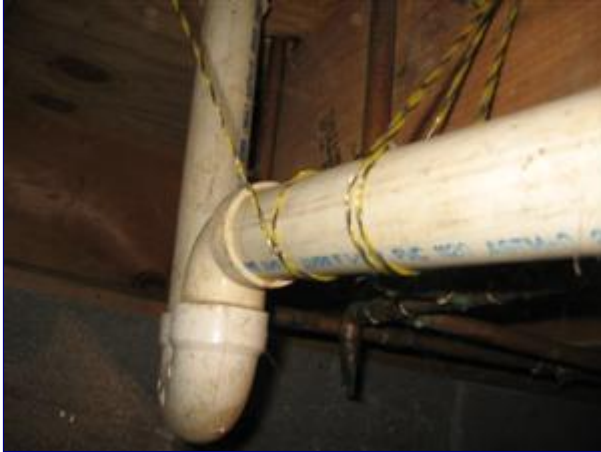
7.0 Picture 1

(1) A couple of leaks were found under the home. One where the tub is located, and one at a joint connection near the tub. Also a piece of rubber was used to cap off a line. This is improper and should be repaired. A licensed plumber should evaluate and make repairs.

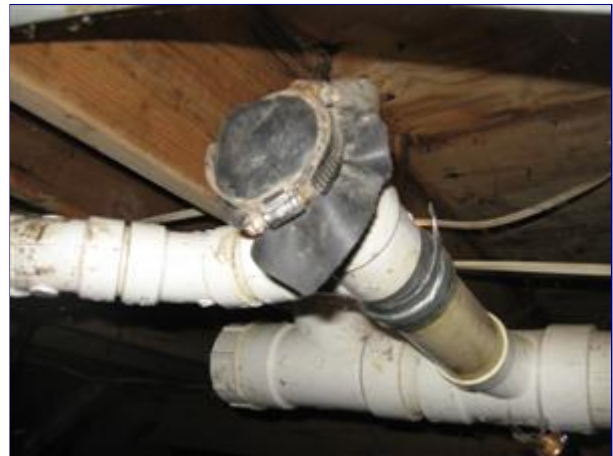
7.0 Picture 4

(2) The washer appears to be draining into the back yard. This will have to be investigated further to confirm this. If so, this should be corrected.

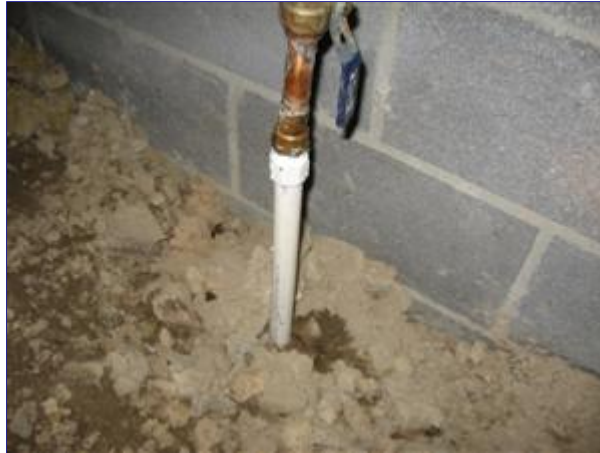
7.3 Picture 1

The main shut off is leaking at the connection.

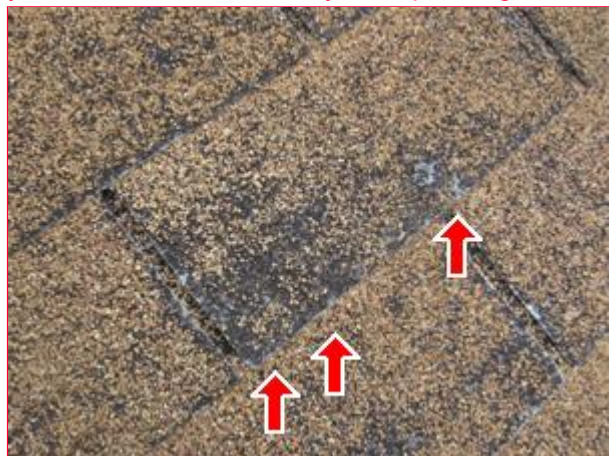
1.0 Picture 1

- ⊘ The roof covering has reached the end of its life expectancy. The covering does need to be replaced. While it could last a year or so, some areas may need patching as leaks develop. Recommend roofer to evaluate further.

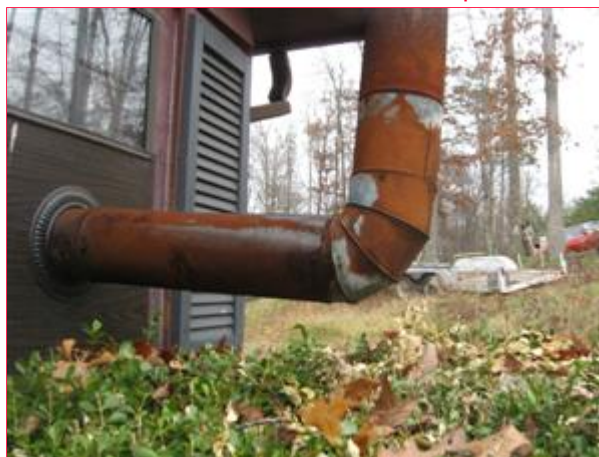
1.2 Picture 1

- ⊘ (1) The pipe collars are deteriorated, and need replacing.
- ⊘ (2) The stove pipe is badly deteriorated and should not be used until replaced.

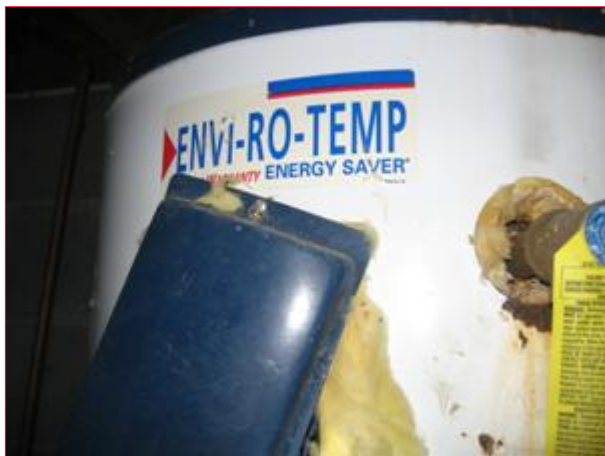
7.2 Picture 1

- ⊘ The water heater is not operating and appears to be badly corroded., Recommend further evaluation and replacement if needed.
